TANK WARFARE

ARMORED COMBAT IN THE NORMANDY CAMPAIGN JUNE-AUGUST 1944

Steven J. Zaloga and George Balin

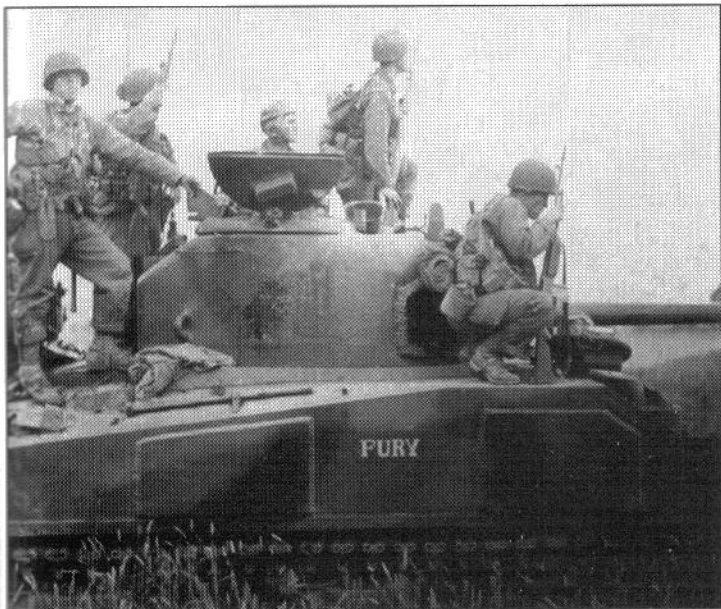
"Fury", a M4 of the 2nd Armored Division, moves forward during the Normandy offensive with infantry onboard. This gives a good view of the applique armor added to the Sherman turret and hull side; the hull panels covered the ammunition racks. (US Army)

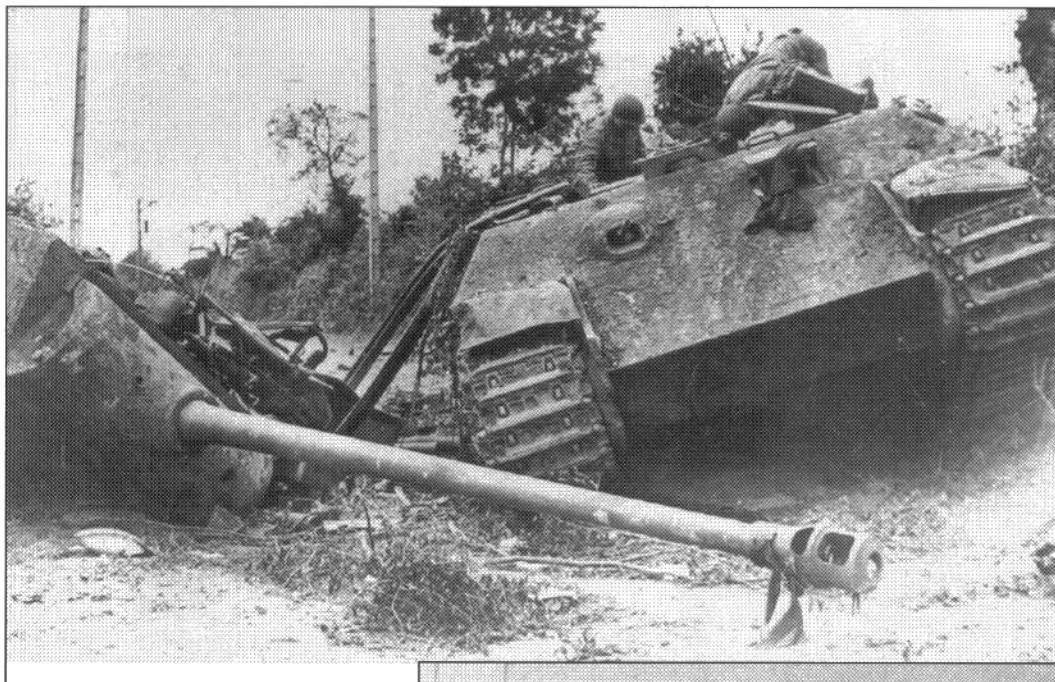
Two GIs inspect a decapitated Panther Ausf. A. This level of damage could only have been accomplished by a catastrophic internal ammunition explosion, usually caused by a penetration of the hull armor by tank fire. (US Army)

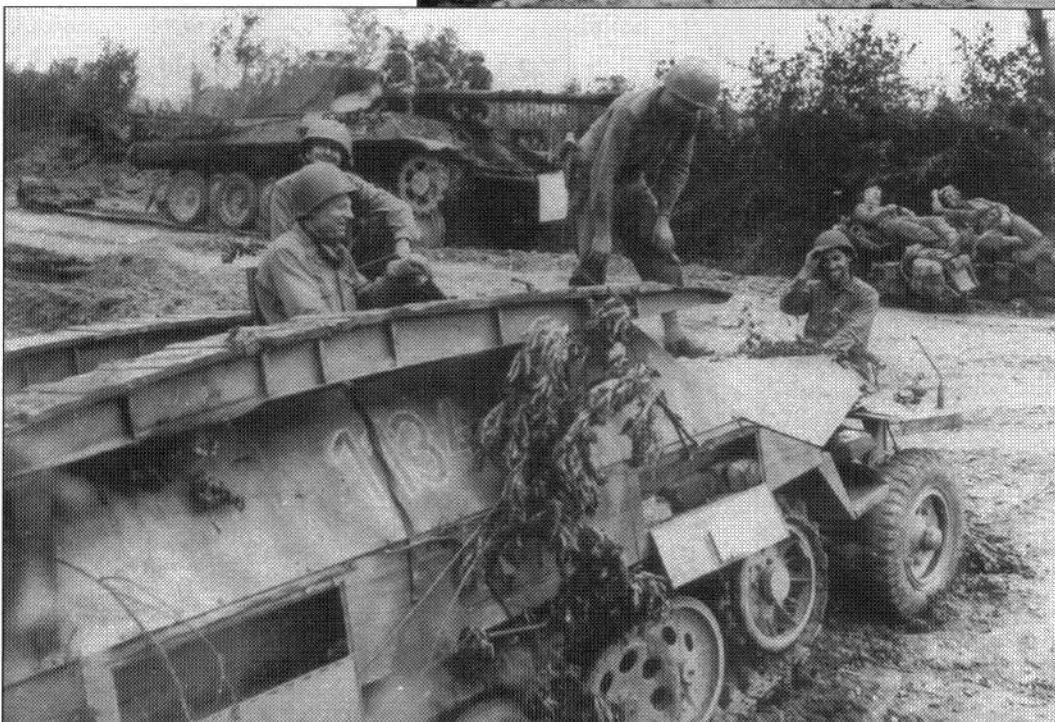
GIs examine knocked out German armor on 26 July during Operation Cobra on the road to Periers. The nearest vehicle is a Sd.Kfz. 251/7 engineer vehicle with a small gap-filling bridge mounted on the superstructure. In the background is a knocked out Panther Ausf. A. Both vehicles were probably from Panzer Lehr Division. (US Army)

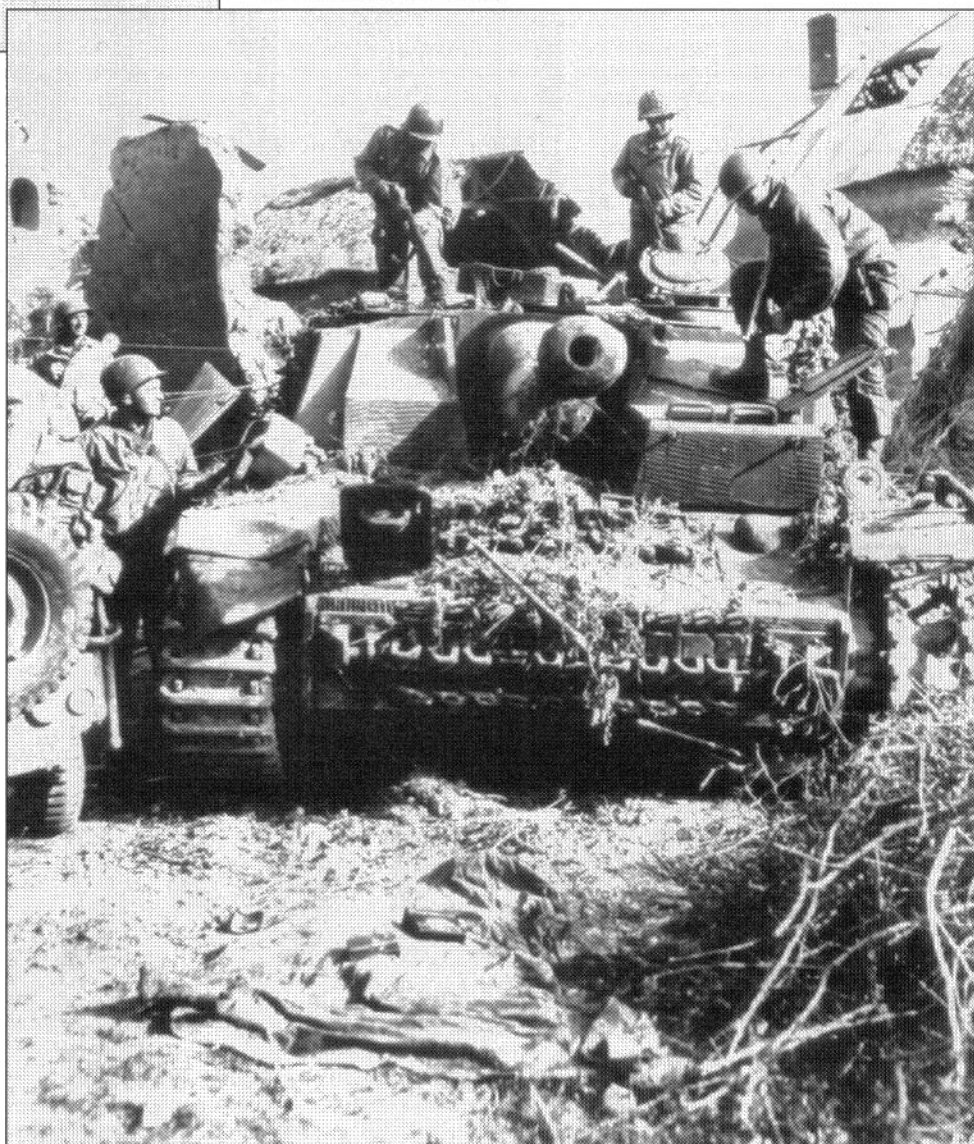
US troops inspect a destroyed StuG IV on 29 July during the breakout. This assault gun was based on the Pz.Kpfw. IV chassis instead of the more common StuG III on the Pz.Kpfw. III chassis. The troops are probably looking for booby-traps, which was a common German ploy when abandoning equipment. (US Army)

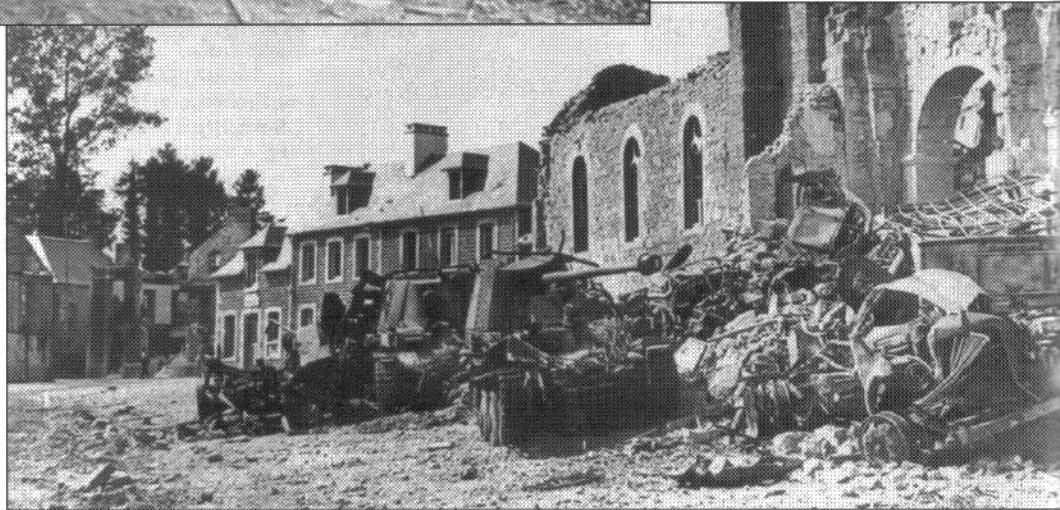
Roncey was a key town sandwiched between the 2nd and 3rd Armored Divs. during Operation Cobra. Here is a view of a pair of 7.5 cm Pz.Jaeger 38(t) Ausf. M (Sd.Kfz. 138) tank destroyers of the SS-Pz.Jg.Abt. 2 of the 2.SS-Pz.Div. lying amidst the wreckage of the town church in Roncey on 30 July 1944. These vehicles were probably knocked out by air strikes. (US Army)

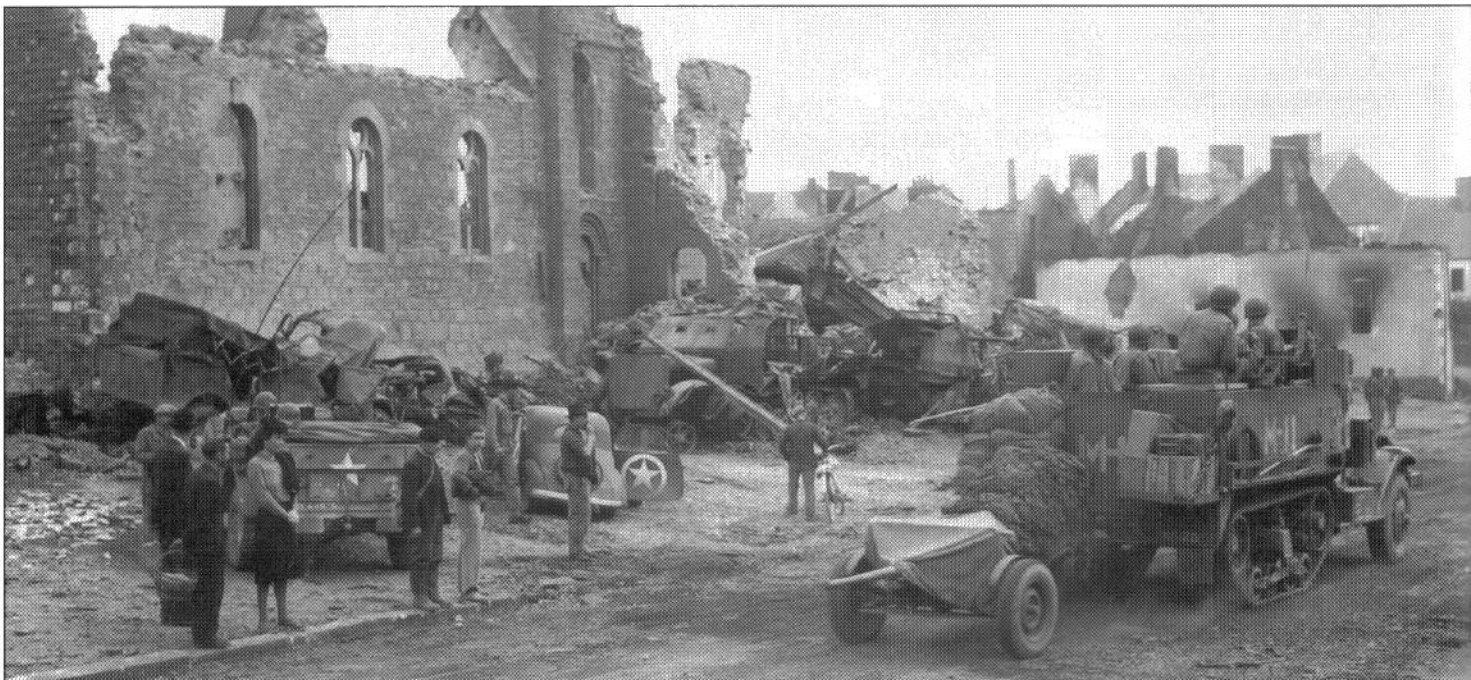
Another view of Roncey on 1 August as troops of the 3rd Armored Div. pass through. This photo is taken from the opposite end of the church, and the rear of one of the tank destroyers seen in the previous photo is evident immediately behind the US M3A1 half-track personnel carrier. Also in the wreckage is a destroyed Sd.Kfz. 7 fitted with a quaduple 20mm anti-aircraft gun, one of the most effective German air defense weapons in Normandy and the bane of Allied fighter bombers. The M3A1 half-track is towing a 37mm anti-tank gun, a weapon wholly inadequate by 1944. (US Army)

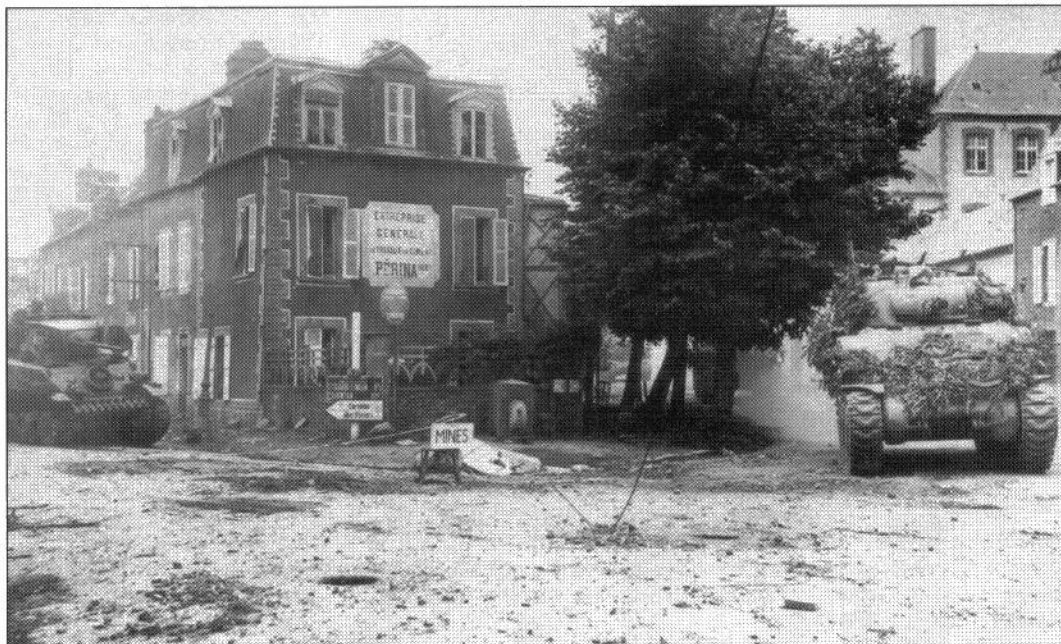
A M4 medium tank of 4th Armored Div. makes its way through Coutances on 30 July 1944. The city was taken by 4th Armored Div. on the evening of 28 July and to the left is a M5A1 light tank that was disabled during this operation by a mine which blew off its right track. Engineers have subsequently taped off the wreckage and placed a sign warning off other units. (US Army)

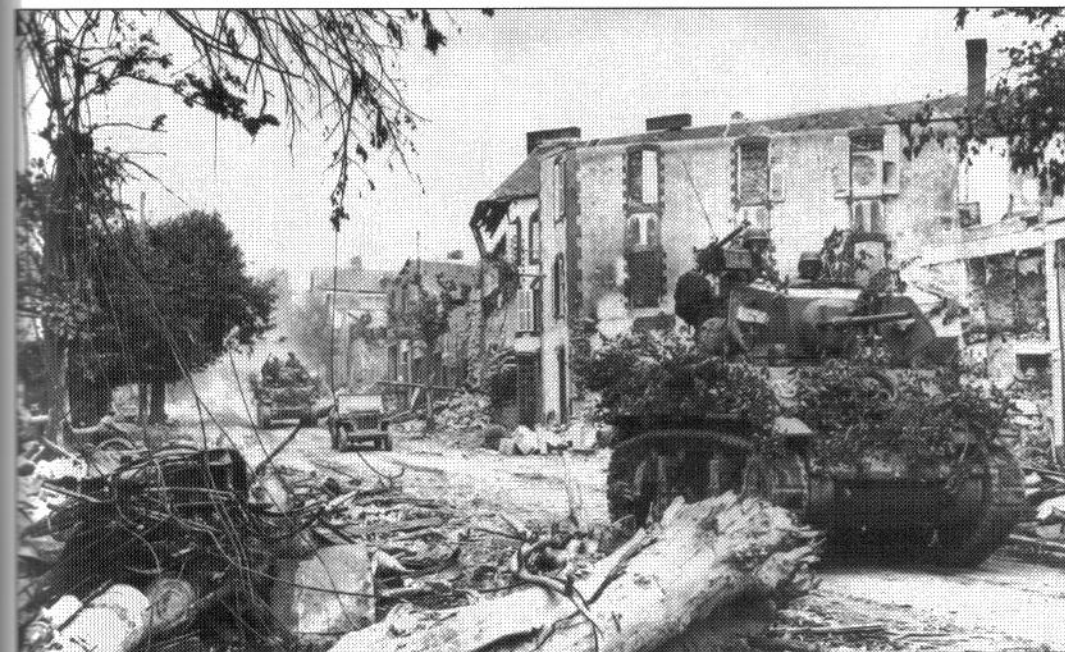
A M5A1 light tank makes its way through the ruined streets of Coutances on 30 July. Several of the battalions of this division festooned their tanks with foliage camouflage before the breakthrough as is very evident on this light tank. By Normandy, the M5A1 light tank was hopelessly armed, and its 37mm gun was effective only against lightly armored German vehicles. The better armed M24 light tank did not appear until December 1944. (US Army)

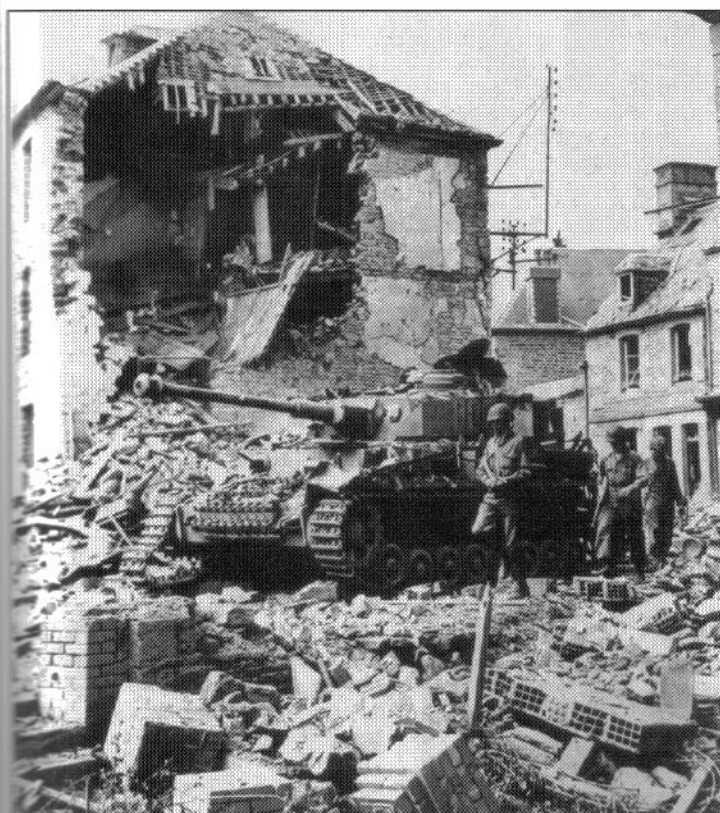
US infantry advance through the ruins of Pont de Farcy on 3 August 1944. The abandoned Pz.Kpfw. IV is believed to have been from the 2nd Panzer Div. and was apparently abandoned after losing its right track in the rubble. (US Army)

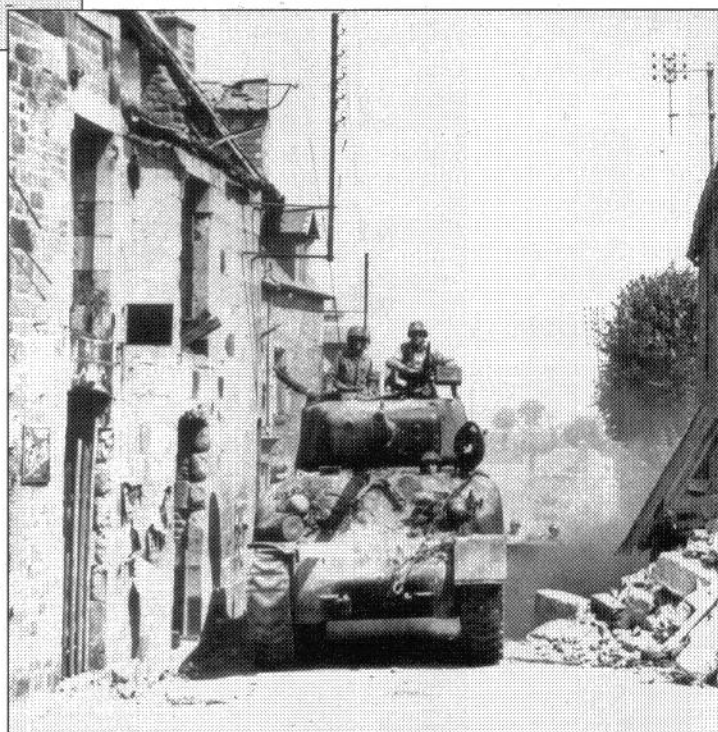
An M4A1(76) W medium tank of the 67th Arm'd. Regt., 2nd Arm'd. Div. enters St. Sever Calvados on 3 August 1944. The US Army began receiving its first 76mm-armed M4A1 tanks in June, immediately before the invasion but there was little initial enthusiasm for them due to their poor high-explosive projectile and the logistical complications of operating 75mm and 76mm gun armed tanks together. After meeting the Panther, the attitude quickly changed and units clamored to get more of these tanks as soon as possible. They were not very effective against the Panther except when firing "souped-up HVAP", a new type of high velocity projectile that was in short supply until 1945. (US Army)

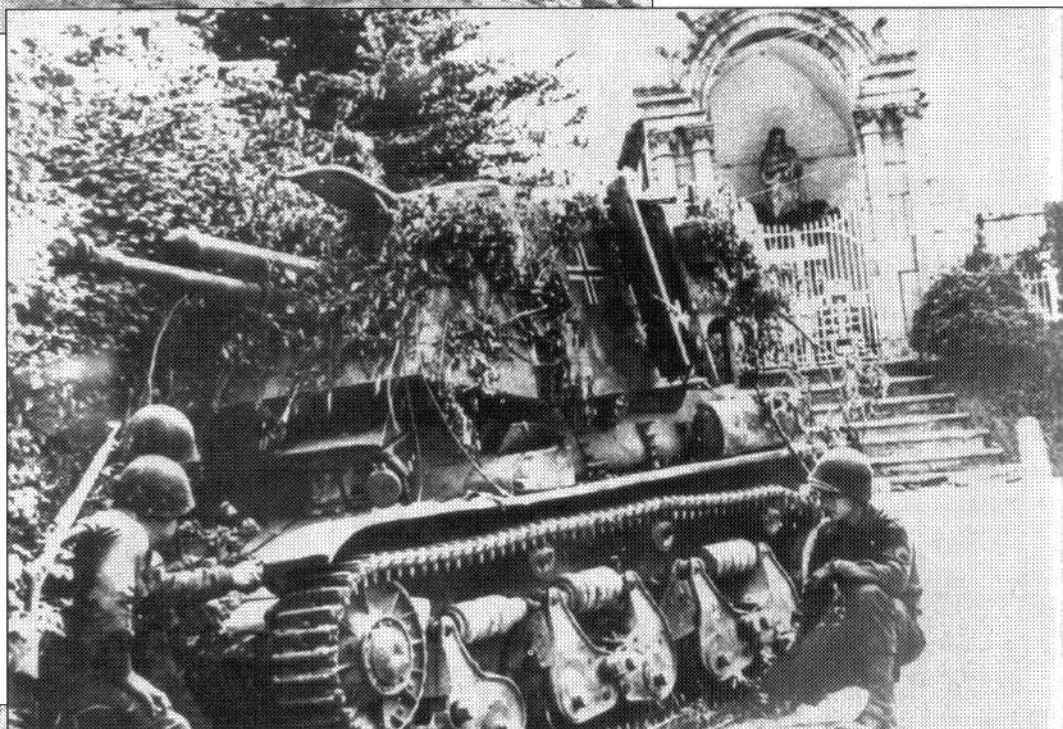
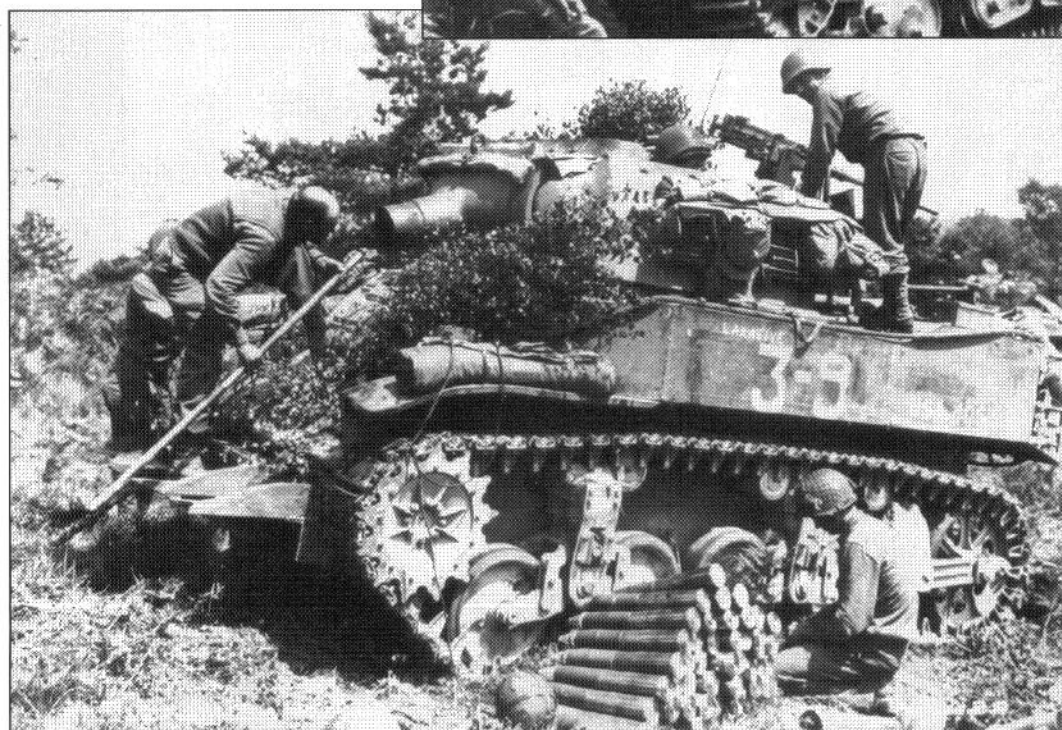
The crew of a M8 75mm HMC named "Laxative" of the 3rd Armored Div. prepare their vehicle for combat on 9 August 1944 during the fighting with the 2.Pz.Div and 1.SS-Pz.Div around Mortain. Notice that the vehicle is fitted with a Culin hedgerow cutter on the bow. The M8 was an assault gun version of the M5A1 light tank, substituting an open-topped turret with 75mm howitzer for the usual 37mm gun turret. They were deployed in armored infantry battalions for fire support in place of the older T30 75mm HMC after 1943. (US Army)

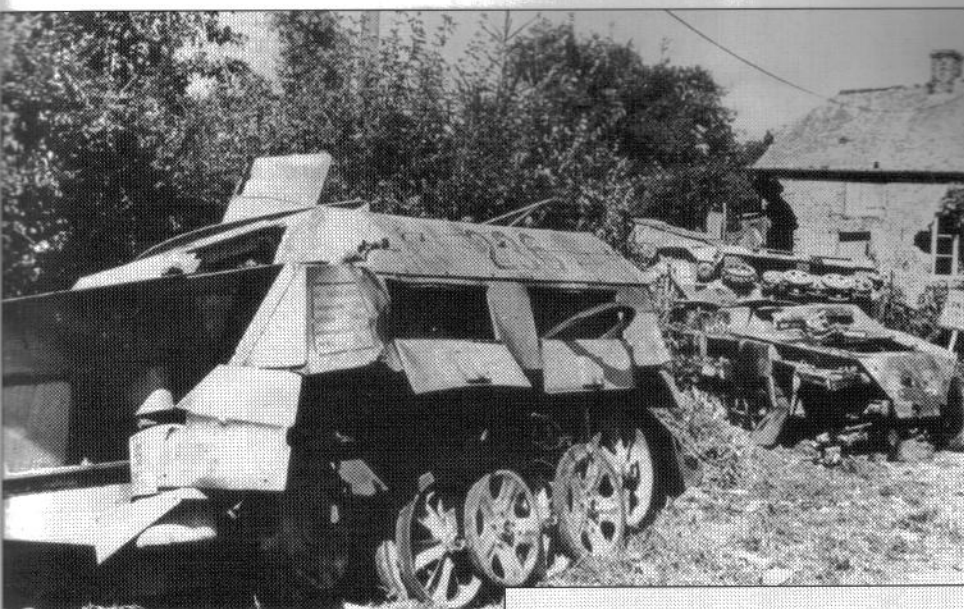
Another view of the knocked out half-track armored car unit from the 2.Pz.Div. on 14 August. As is evident in this view, the vehicle to the right was destroyed by two anti-tank gun penetrations on the bow plate. The vehicle in the foreground, from the 2nd company, has apparently taken several hits including one near the driver's visor. (US Army)

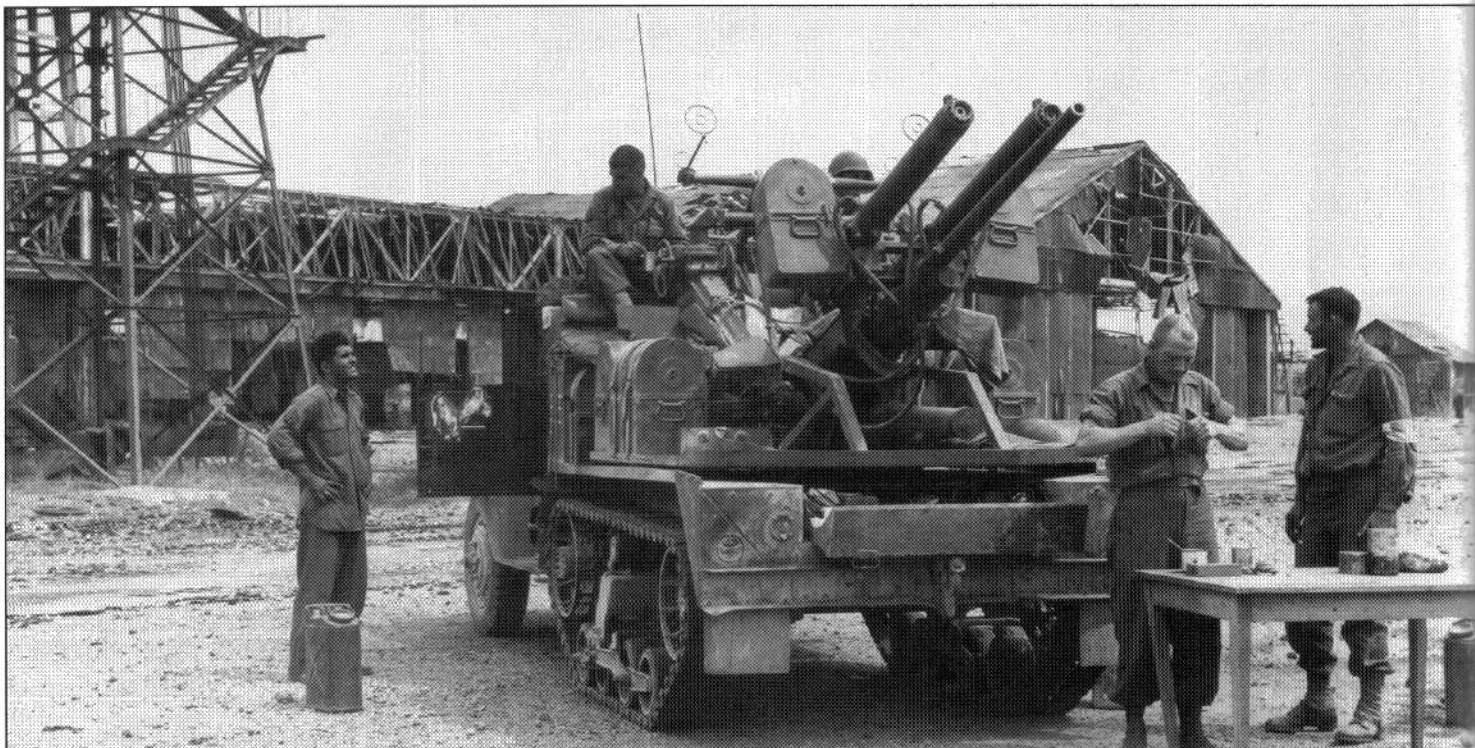
A T28 combination gun motor carriage of the 443rd AAA Bn. guards St. Rapheal air base in southern France on 17 August after the landings. The T28 was an expedient anti-aircraft vehicle rushed into service for the North African landings in 1942. A small number remained in service in the Mediterranean theatre, but in northwestern France, it had been replaced by the improved M15 and M15A1 CGMCs. (US Army)

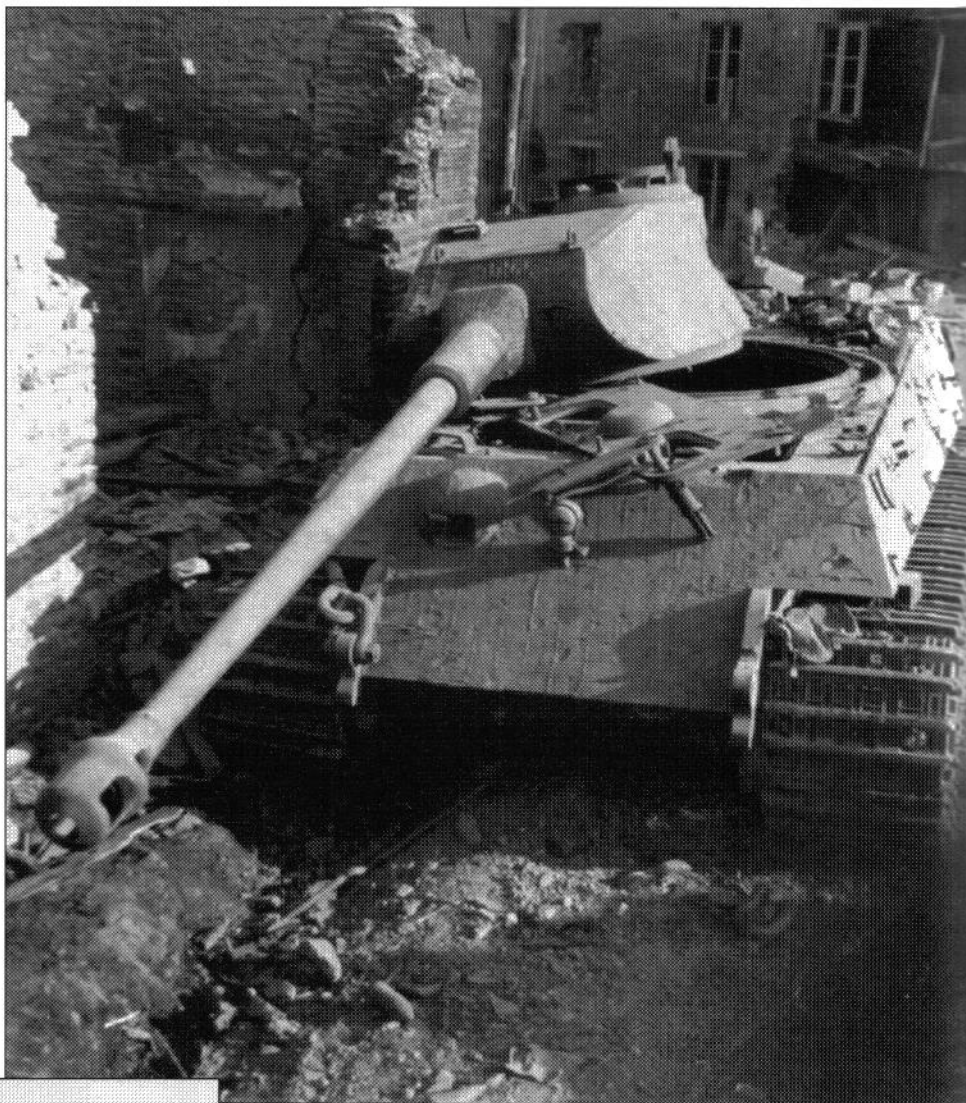
On 6 August, the town of le Plessis Grimoult, to the east of Mt. Pincon, was taken in a day-long hand-to-hand battle by the British 130th Brigade. Among the debris in the city was this King Tiger of s.Pz.Abt. 503. The tank has obviously suffered from an internal explosion which has knocked off its turret. It is unclear how this tank was knocked out; some sources indicate it was hit by rocket fire from a Typhoon. The King Tiger was the heaviest tank to see combat in Normandy, but it was new and suffered from serious technical shortcomings. Only two companies of this new tank were committed to the fighting, and all were lost by the end of August.

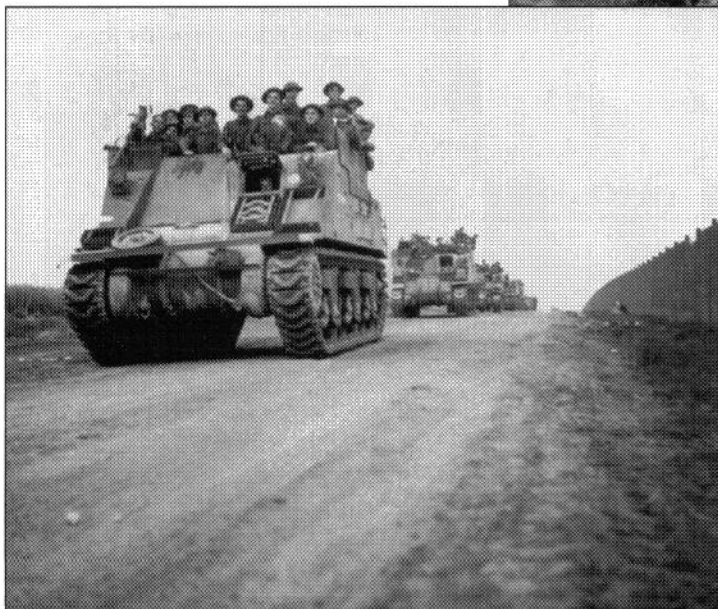
The stinging losses of infantry in the July fighting led the British to develop more satisfactory means to transport the forward waves of infantry. During the attack towards Falaise beginning on 8 August, Operation Totalize, the first use was made of improvised armored troop carriers, variously dubbed "holy rollers" or "defrocked priests". The names of course stemmed from the use of M7 Priest self-propelled howitzers for the conversion. By this time, the Royal Artillery was standardizing on the Sexton 25 pdr., so the Lend-Lease M7 Priests were converted to this role by removing the howitzer and adding bench seats. A similar conversion was made later using surplus Canadian Ram tanks, resulting in the Ram Kangaroos. (The Tank Museum)

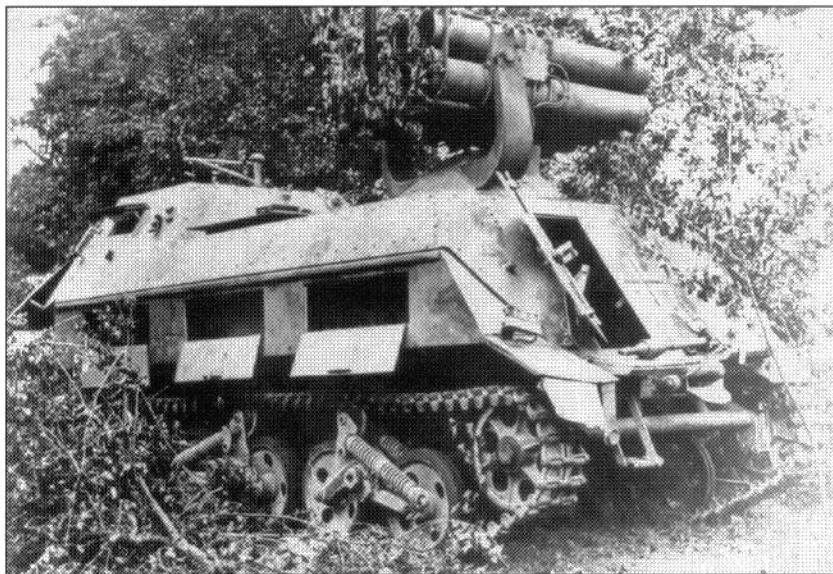
The Falaise Gap was filled with abandoned or destroyed equipment that had to be left behind by the retreating German forces. This is a 15 cm Panzerwerfer 42 auf SF (Sd.Kfz. 4/1), a 105mm multiple rocket launcher based on an armored version of the Opel Maultier half-track truck. (US National Archives, Federal Records Center-Suitland)

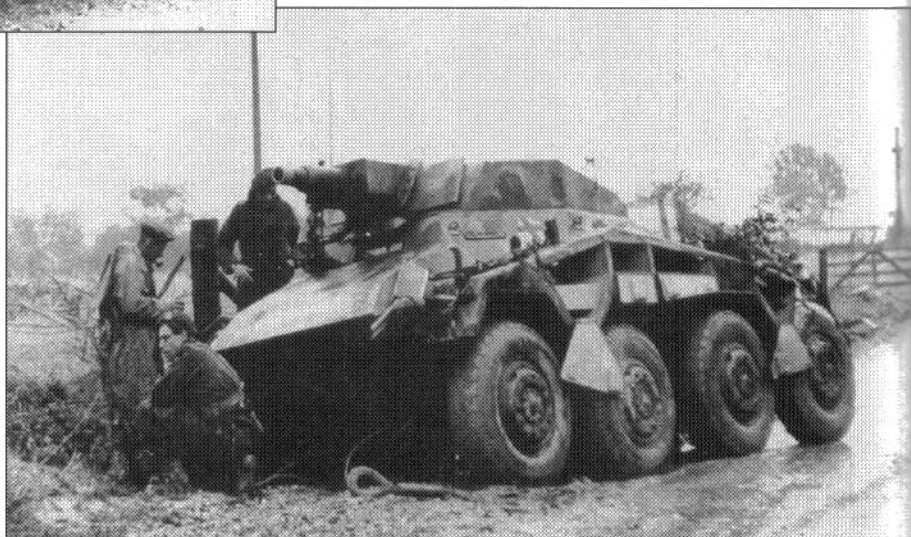
An abandoned Sd.Kfz. 234/3 s.Panzerspahwagen (7.5cm) of the 116.Panzer Div. is inspected by British troops. This was a howitzer-armed version of the Puma armored car, and a platoon of six of these were attached to the heavy armored car companies of the panzer divisions for additional fire support. (The Tank Museum)

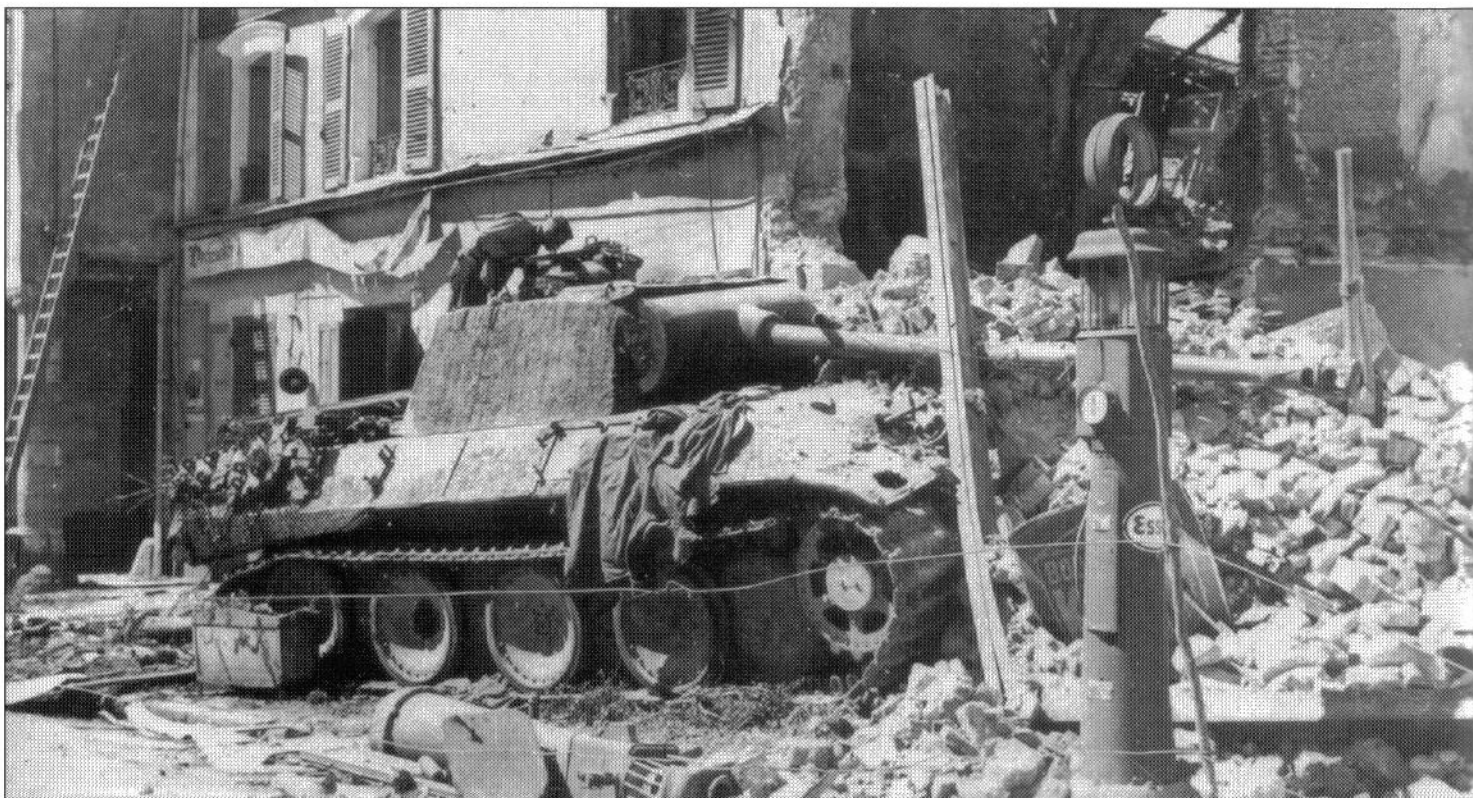
A US ordnance officer inspects a Panther Ausf. A lying abandoned in a shattered French town in August 1944. The German army lost over 400 Panther tanks during the Normandy fighting, most of them the standard Ausf. A version as seen here. (US Army)

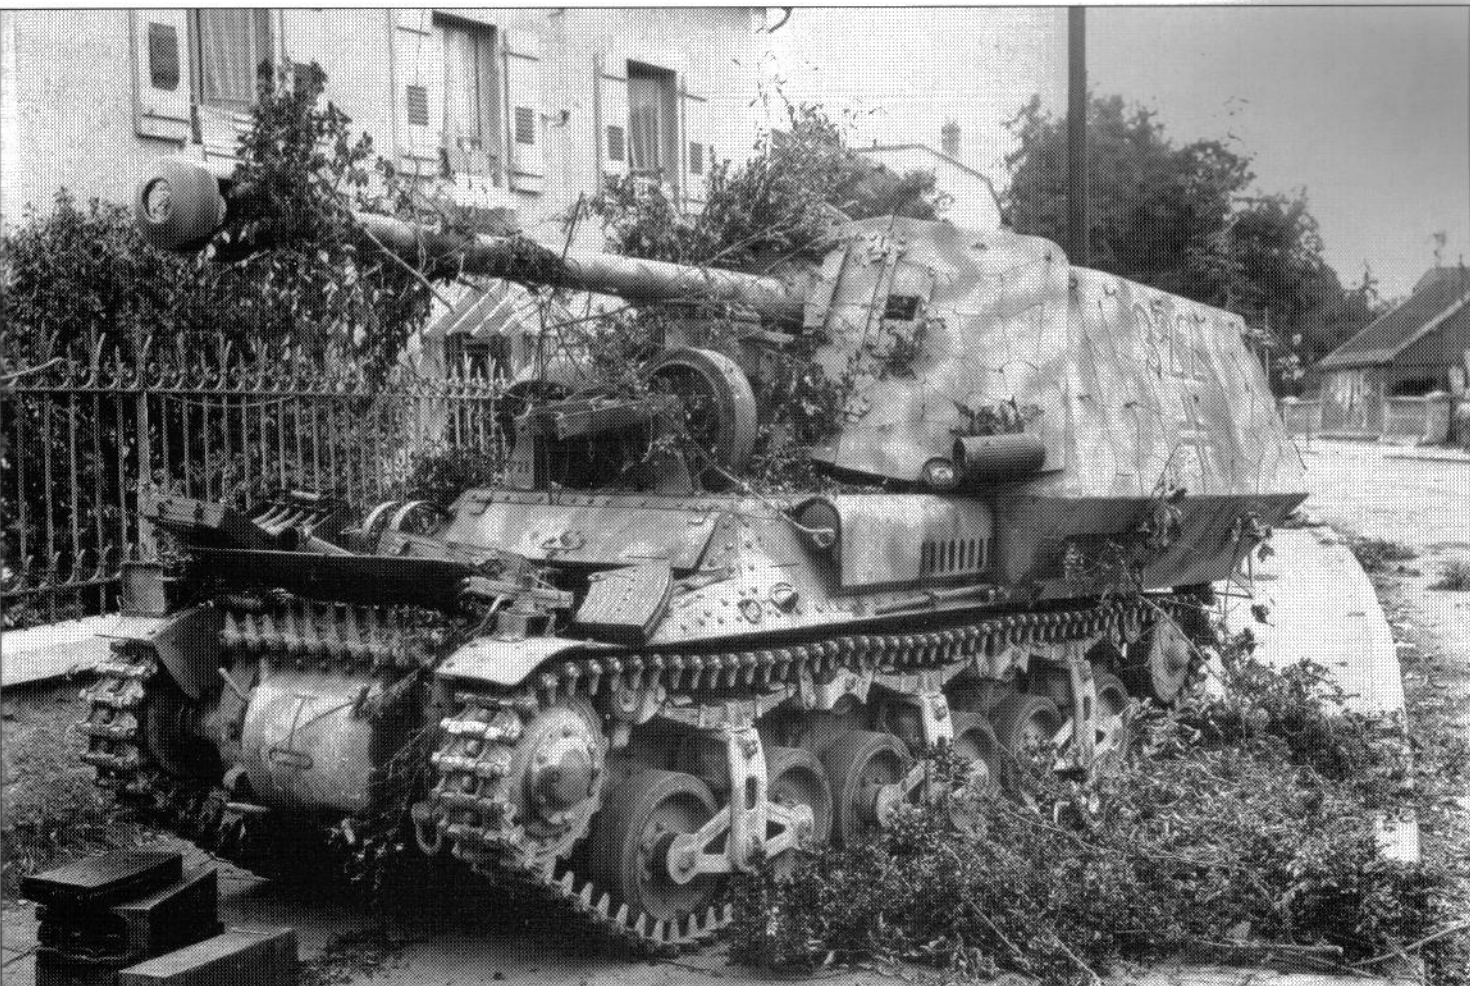
A 7.5cm PaK 40 auf Chenillette (f) lies abandoned in Vesoul, France. This was another of the Becker conversions, consisting of a German 75mm PaK 40 anti-tank gun mounted on a captured Chenillette Lorraine armored transporter. The Chenillette Lorraine was a popular basis for such conversions, as they were nearly all brand new in 1940, and many had not even been issued to French troops. (US Army)

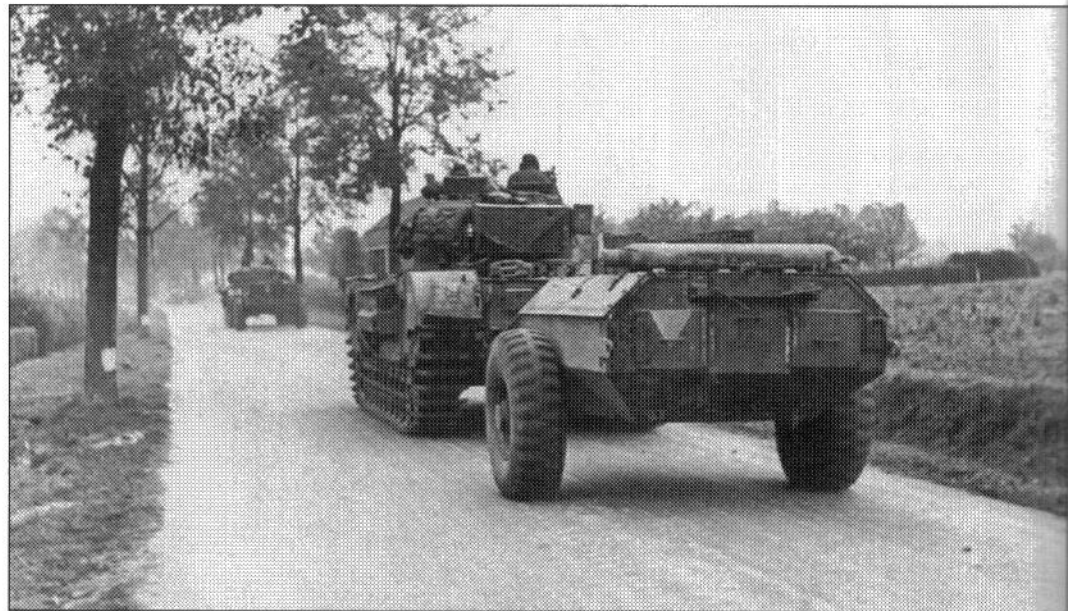
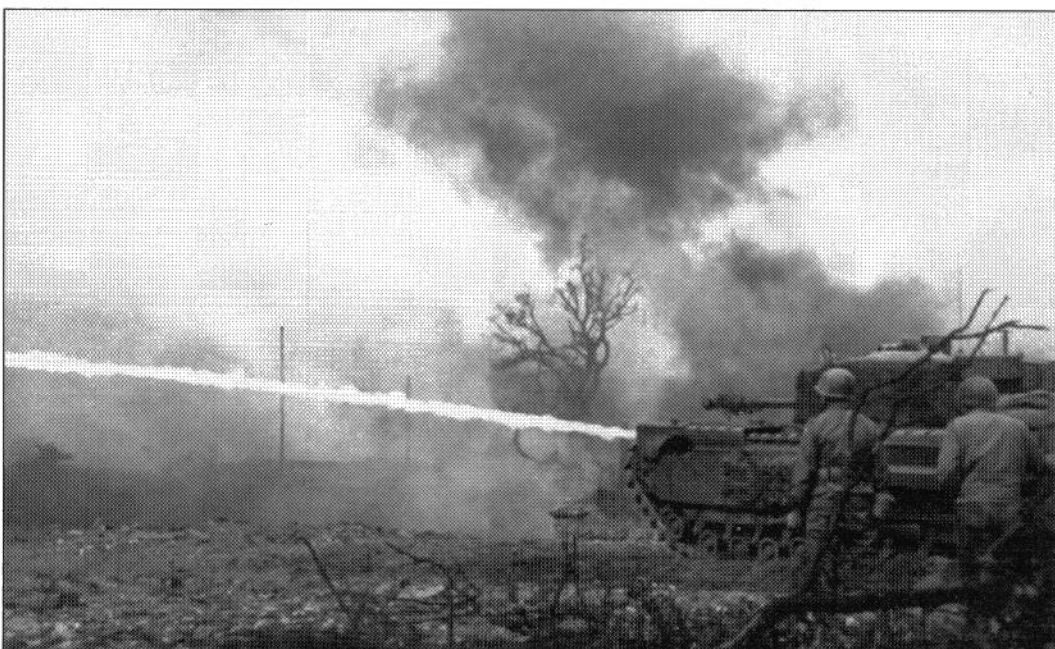
The Churchill Crocodiles were temporarily attached to a 4th Armored Division group trying to reduce German pockets of resistance in Brest. The Crocodile mounted a flamethrower in the glacis plate in place of the usual machine gun, and an armored trailer in the rear provided the fuel and pressurized air. (The Tank Museum)
